# Tree Survey and Arboricultural Impact Assessment Report (For Development Application)

Report Prepared for: **Ocean Gardens Pty Ltd.**  
Landowners: Julie Wyatt and Shelley Terril  
Care Of: **Doepel Marsh Architects**  
Contact Person: Felicity Coombe  
Address: 61 Forrest Street, Subiaco, W.A. 6008  
PO Box 308 Subiaco WA 6904  
Phone: 9388 2281  
Email: felicityc@doepelmarsh.com.au

Report Date: **29<sup>th</sup> July 2025**

Site Address: **Capel Inn, Capel Drive, Capel, W.A.**

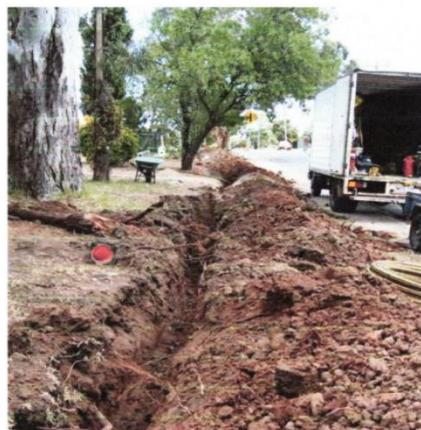
**Photo:** Showing tree root damage from service trenching within the TPZ.
