## *2014 Dalyellup Annual Environmental Report*

**Cristal Pigment Australia Ltd - Kemerton Plant**

This report documents the environmental review of the Dalyellup treated solid residue disposal facility operated by Cristal. The report is submitted to satisfy the following requirements for the period January 2014 - May 2015 for the:

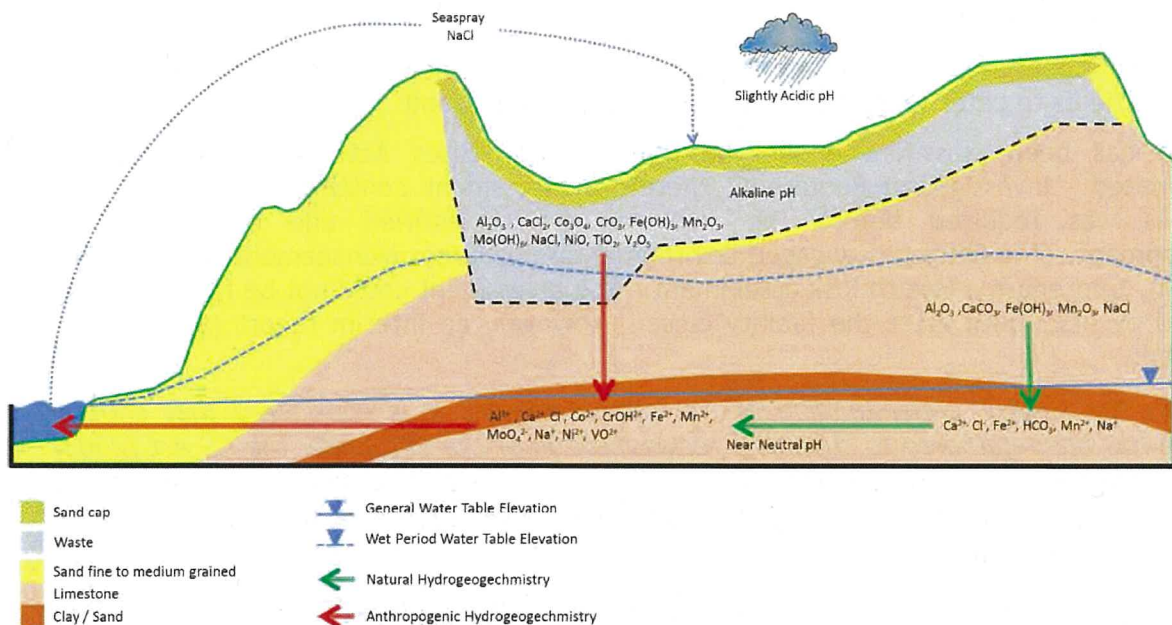
Figure 2 – Conceptual model of the Site<sup>1</sup>

The sediments below the disposal area are calcareous, fine to medium grained sands. They range in depth from 10 to 20 metres. Limestone, sand and sandy clays occur in the area at depths between 10 to 30 metres. Below these sediments are dark grey, silty, micaceous clays. Some heavy minerals and silty organic matter occur throughout the profile. The secondary dunes are overlain by about 0.5 to 1.0 metres of topsoil. The area is underlain by superficial formations, which extend from the ground surface to about 10 metres AHD. The superficial formations form an anisotropic unconfined aquifer, comprising sand and limestone, with a basal section of less permeable silty sand and sandy clay. The depth to the water table is about 10 metres beneath the base of the lagoons and varies with topographic elevation and mounding effects. Seasonal fluctuation is estimated to be 1 to 1.5 metres. The superficial aquifer has a saturated thickness at about 10 metres beneath the disposal site. Groundwater flow through the superficial formation is towards the ocean where discharge occurs across a seawater interface. The hydraulic gradient is about 1:100. Baseline studies, prior to commissioning the site, recorded electrical conductivities in the order of 1,350  $\mu\text{S}/\text{cm}$ , equivalent to about 800 mg/L TDS. Figure 2 shows a hydrogeological conceptual model of the disposal site.
