EXTRACTIVE INDUSTRY (SAND) OPERATIONS PLAN

**LOT 103 BOYANUP ROAD WEST,
STRATHAM**

September 2023

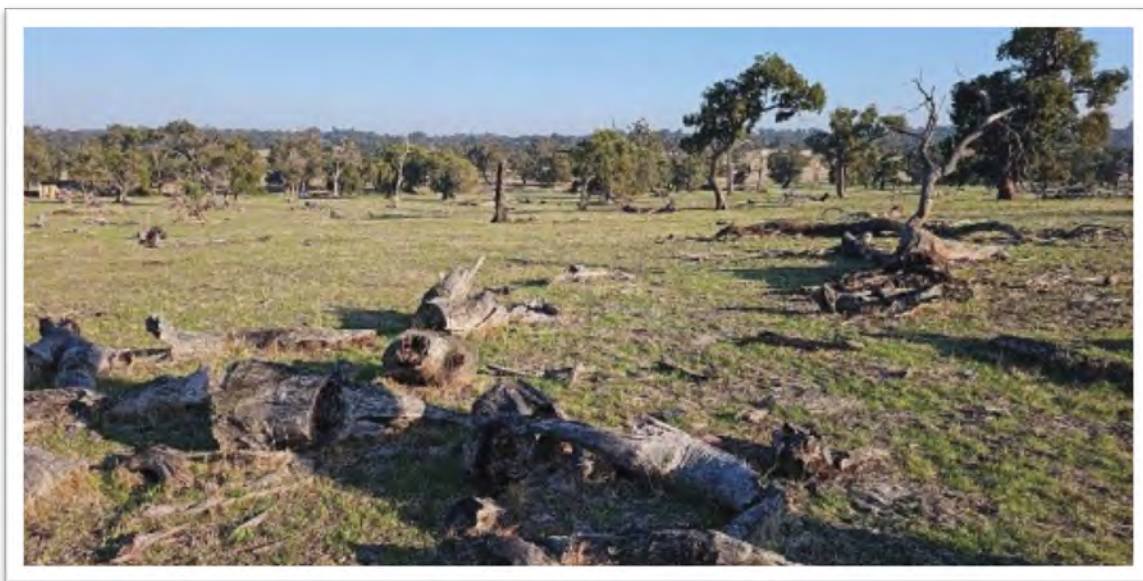
Plate 1. Completely degraded pasture with scattered trees (vegetation at the bottom of the hill is excluded from the extraction footprint).

The vegetation within the subject site is in a 'completely degraded' (Keighery 1994) condition due to prolonged land degradation processes including land clearing, and livestock grazing. A fauna survey was undertaken (Harewood 2023) which describes the vegetation within the subject site as totally degraded 'pasture/bare ground with widely scattered trees including marri (*Corymbia calophylla*), jarrah (*Eucalyptus marginata*), peppermint (*Agonis flexuosa*) and dead unidentified species' (refer to **Plate 1**). Very occasional individuals of the WA Christmas Tree (*Nuytsia floribunda*), Bull Banksia (*Banksia grandis*) and Woody Pear (*Xylomelum occidentale*) were observed during the survey. An area of approximately one hectare in size to the north east of the subject site described as a 'peppermint low woodland with very occasional emergent eucalypts' has been excluded from the extraction footprint (Harewood 2023) (refer to **Plate 2**).

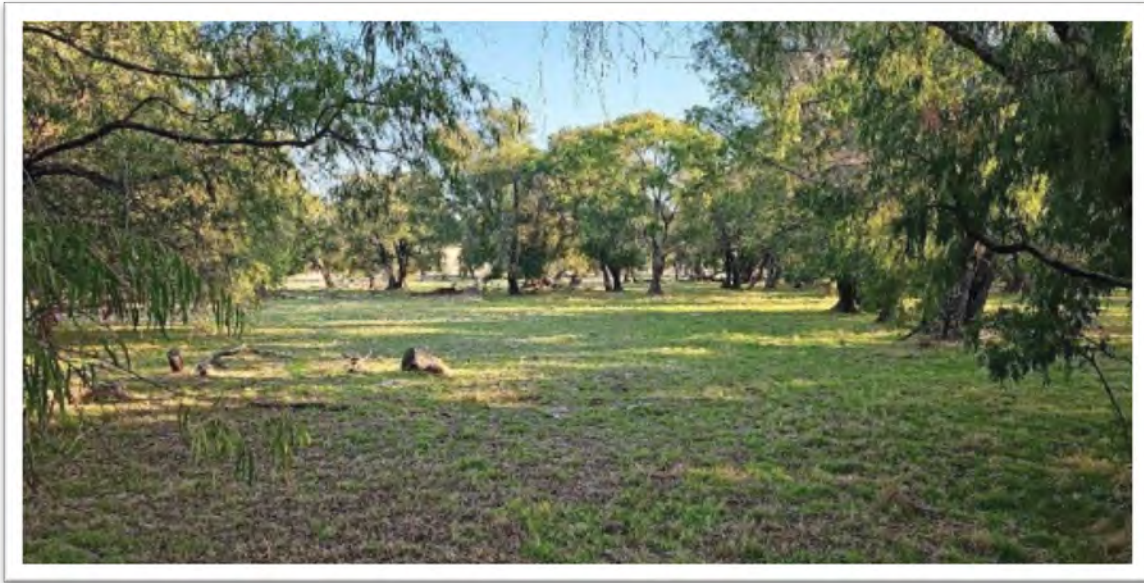
Plate 2. Peppermint low woodland which has been excluded from the extraction footprint.

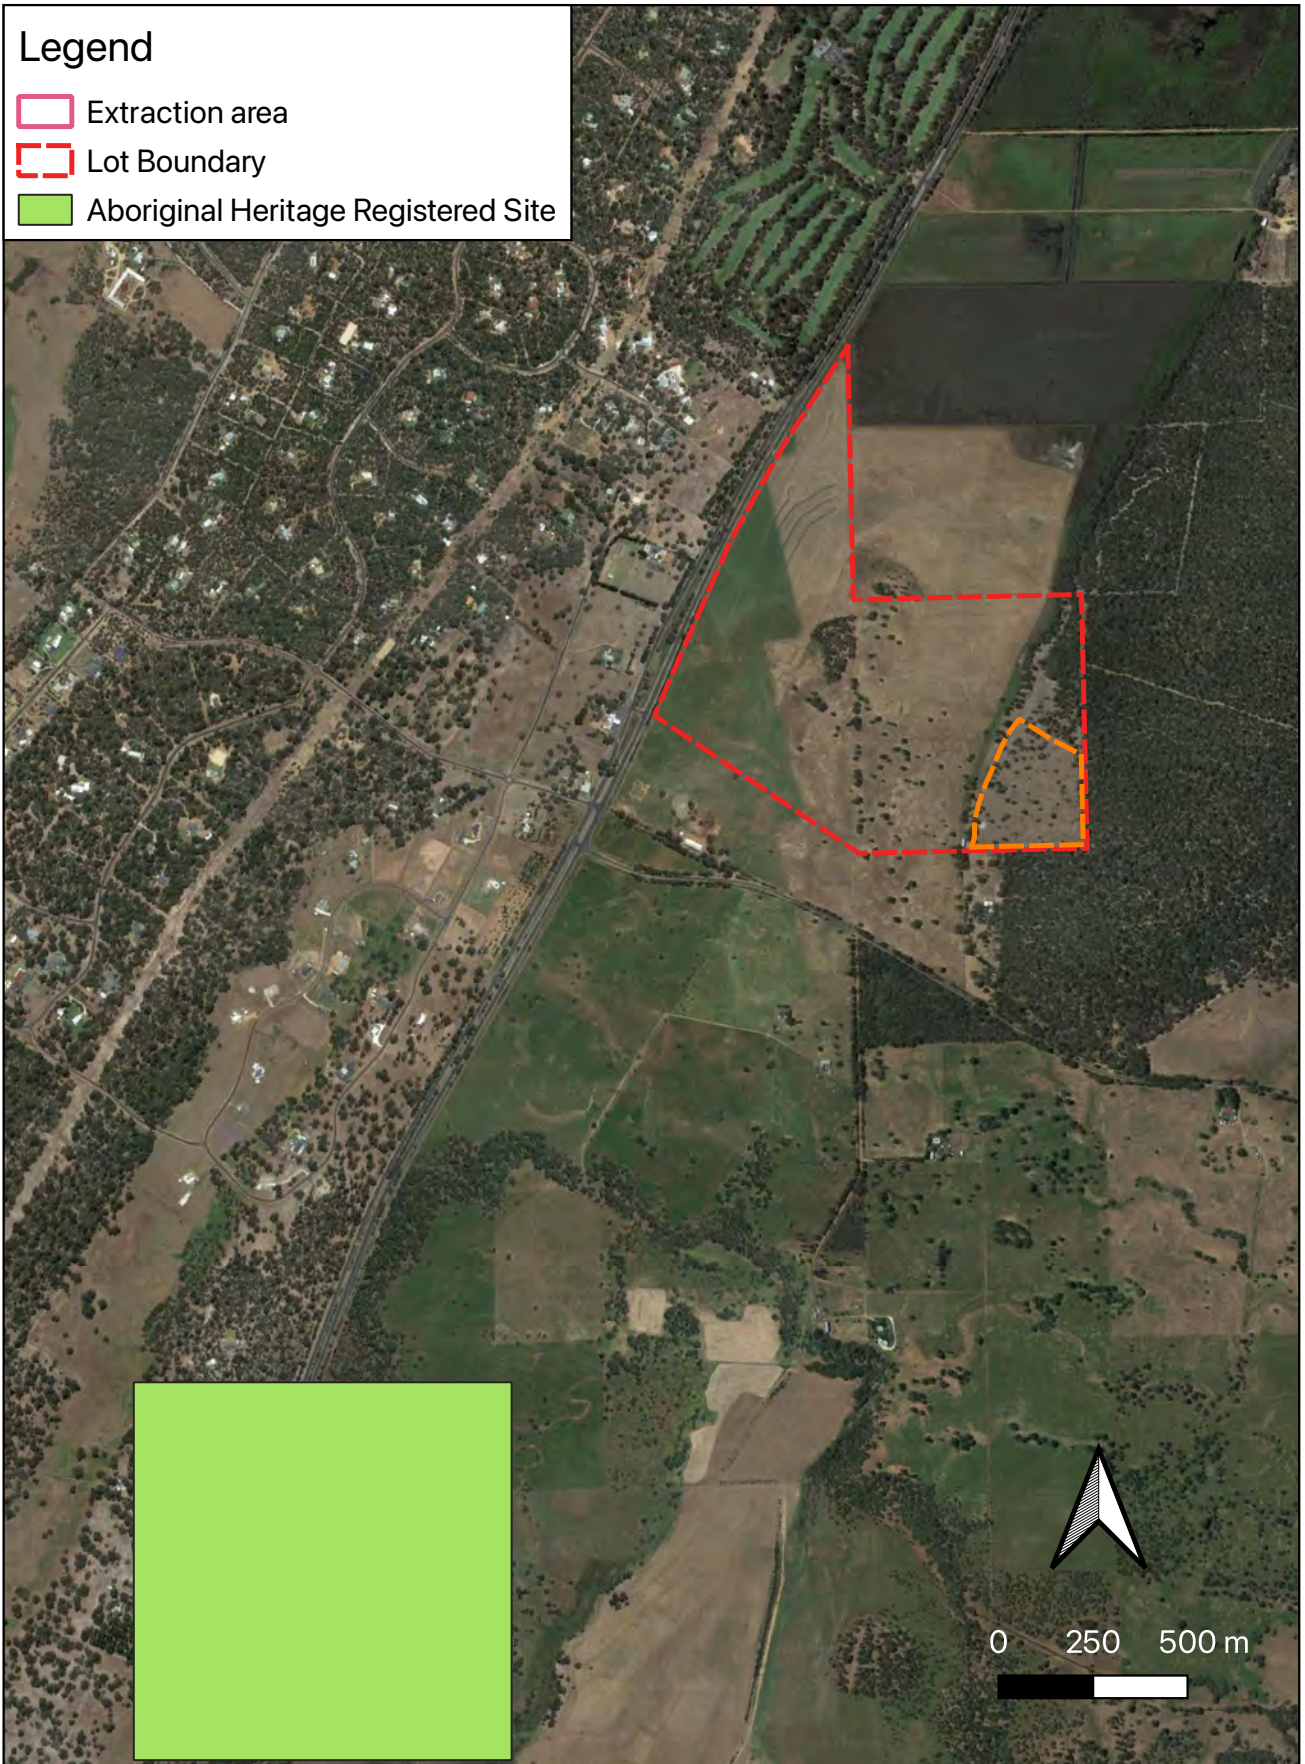
DRAWING TITLE Figure 5 – Aboriginal Heritage Sites

While these surveys did not constitute a comprehensive 'site identification', 'site avoidance' or 'work area/programme clearance' survey, no Aboriginal heritage sites are identified as being present within the subject site. The closest Aboriginal heritage site is the Capel Bussell Highway (ID 5813) located approximately 2 km to the southwest of the excavation area (refer to **Figure 5**).

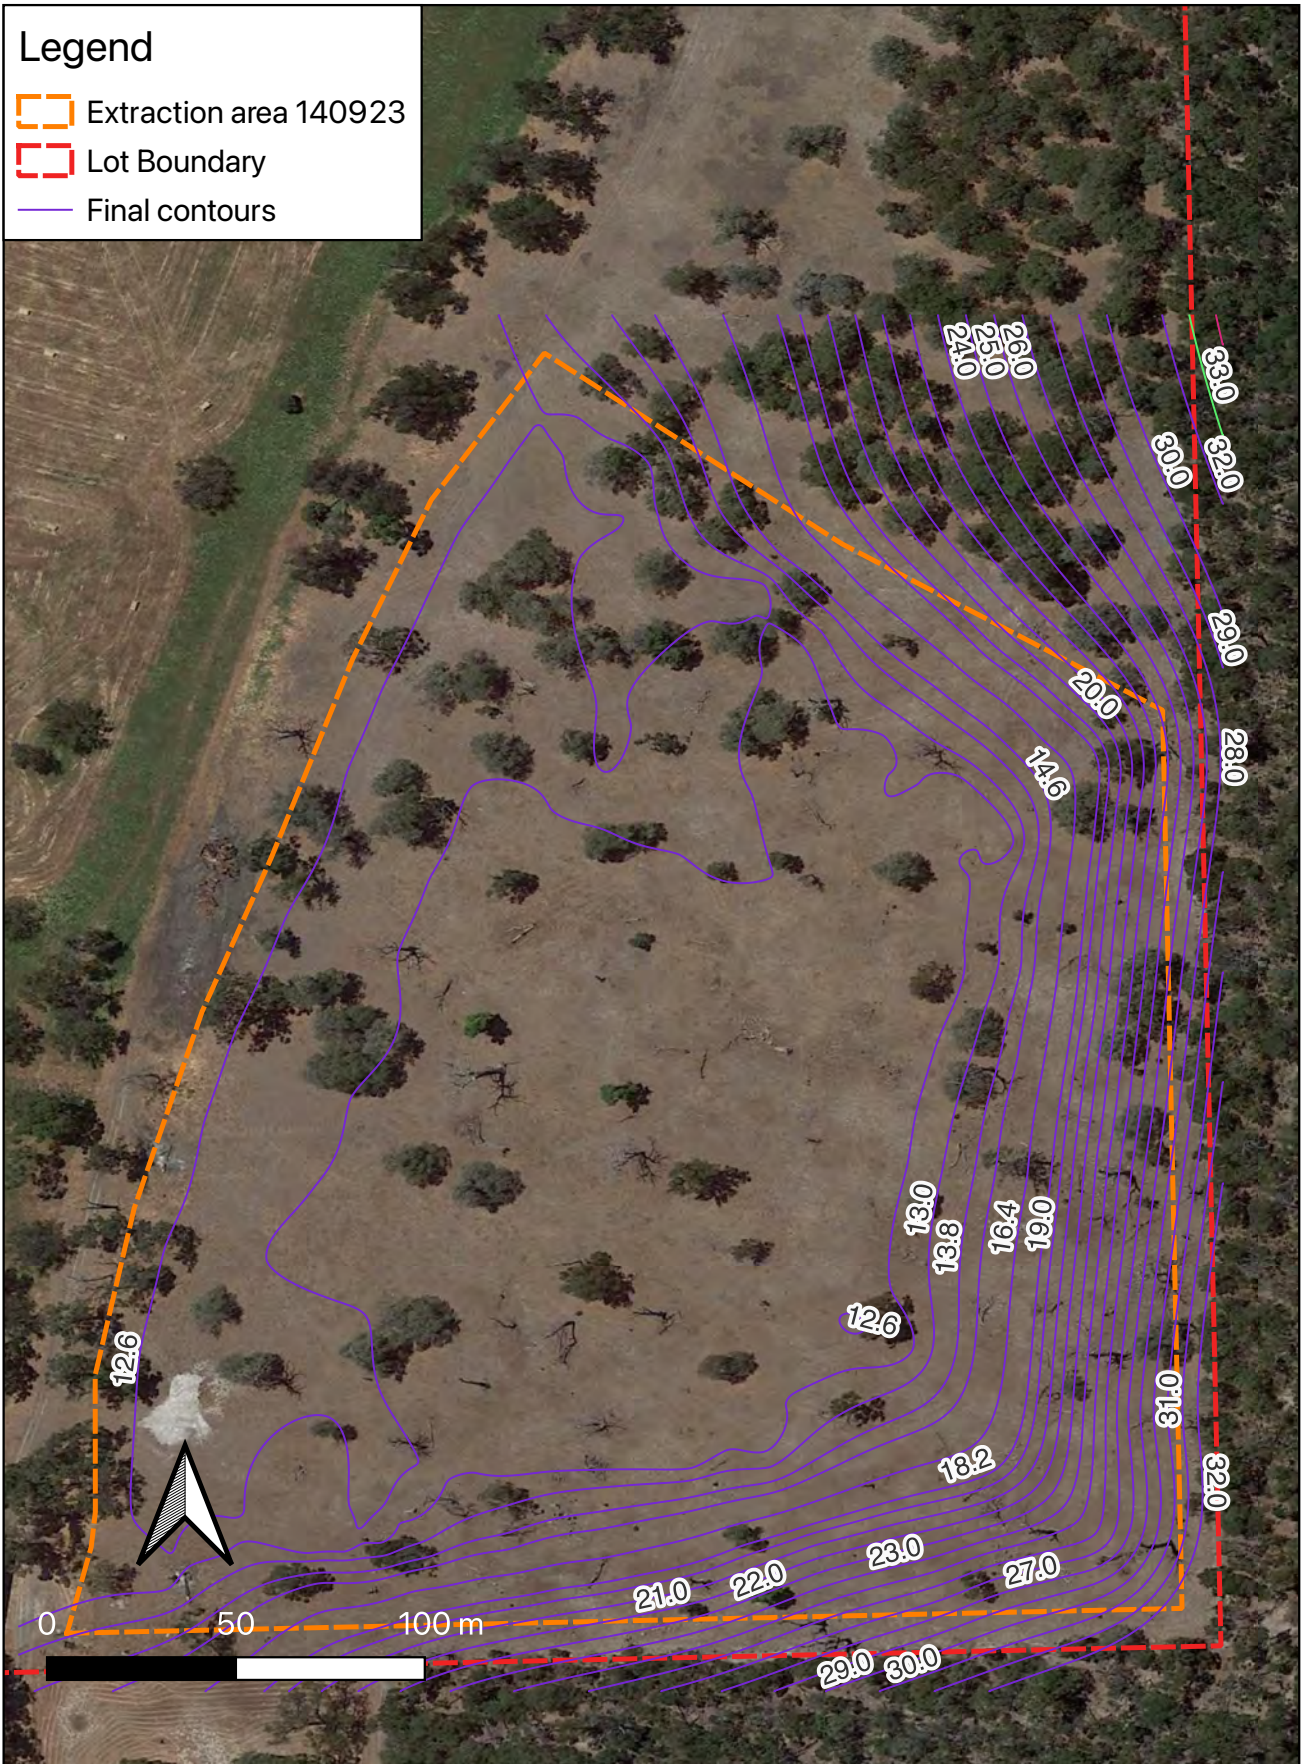
PROJECT Lot 103 (Harris Pit), Stratham
 DRAWING TITLE Figure 8 – Final Contours
 CLIENT Leeuwin Civil Pty Ltd

Final contours

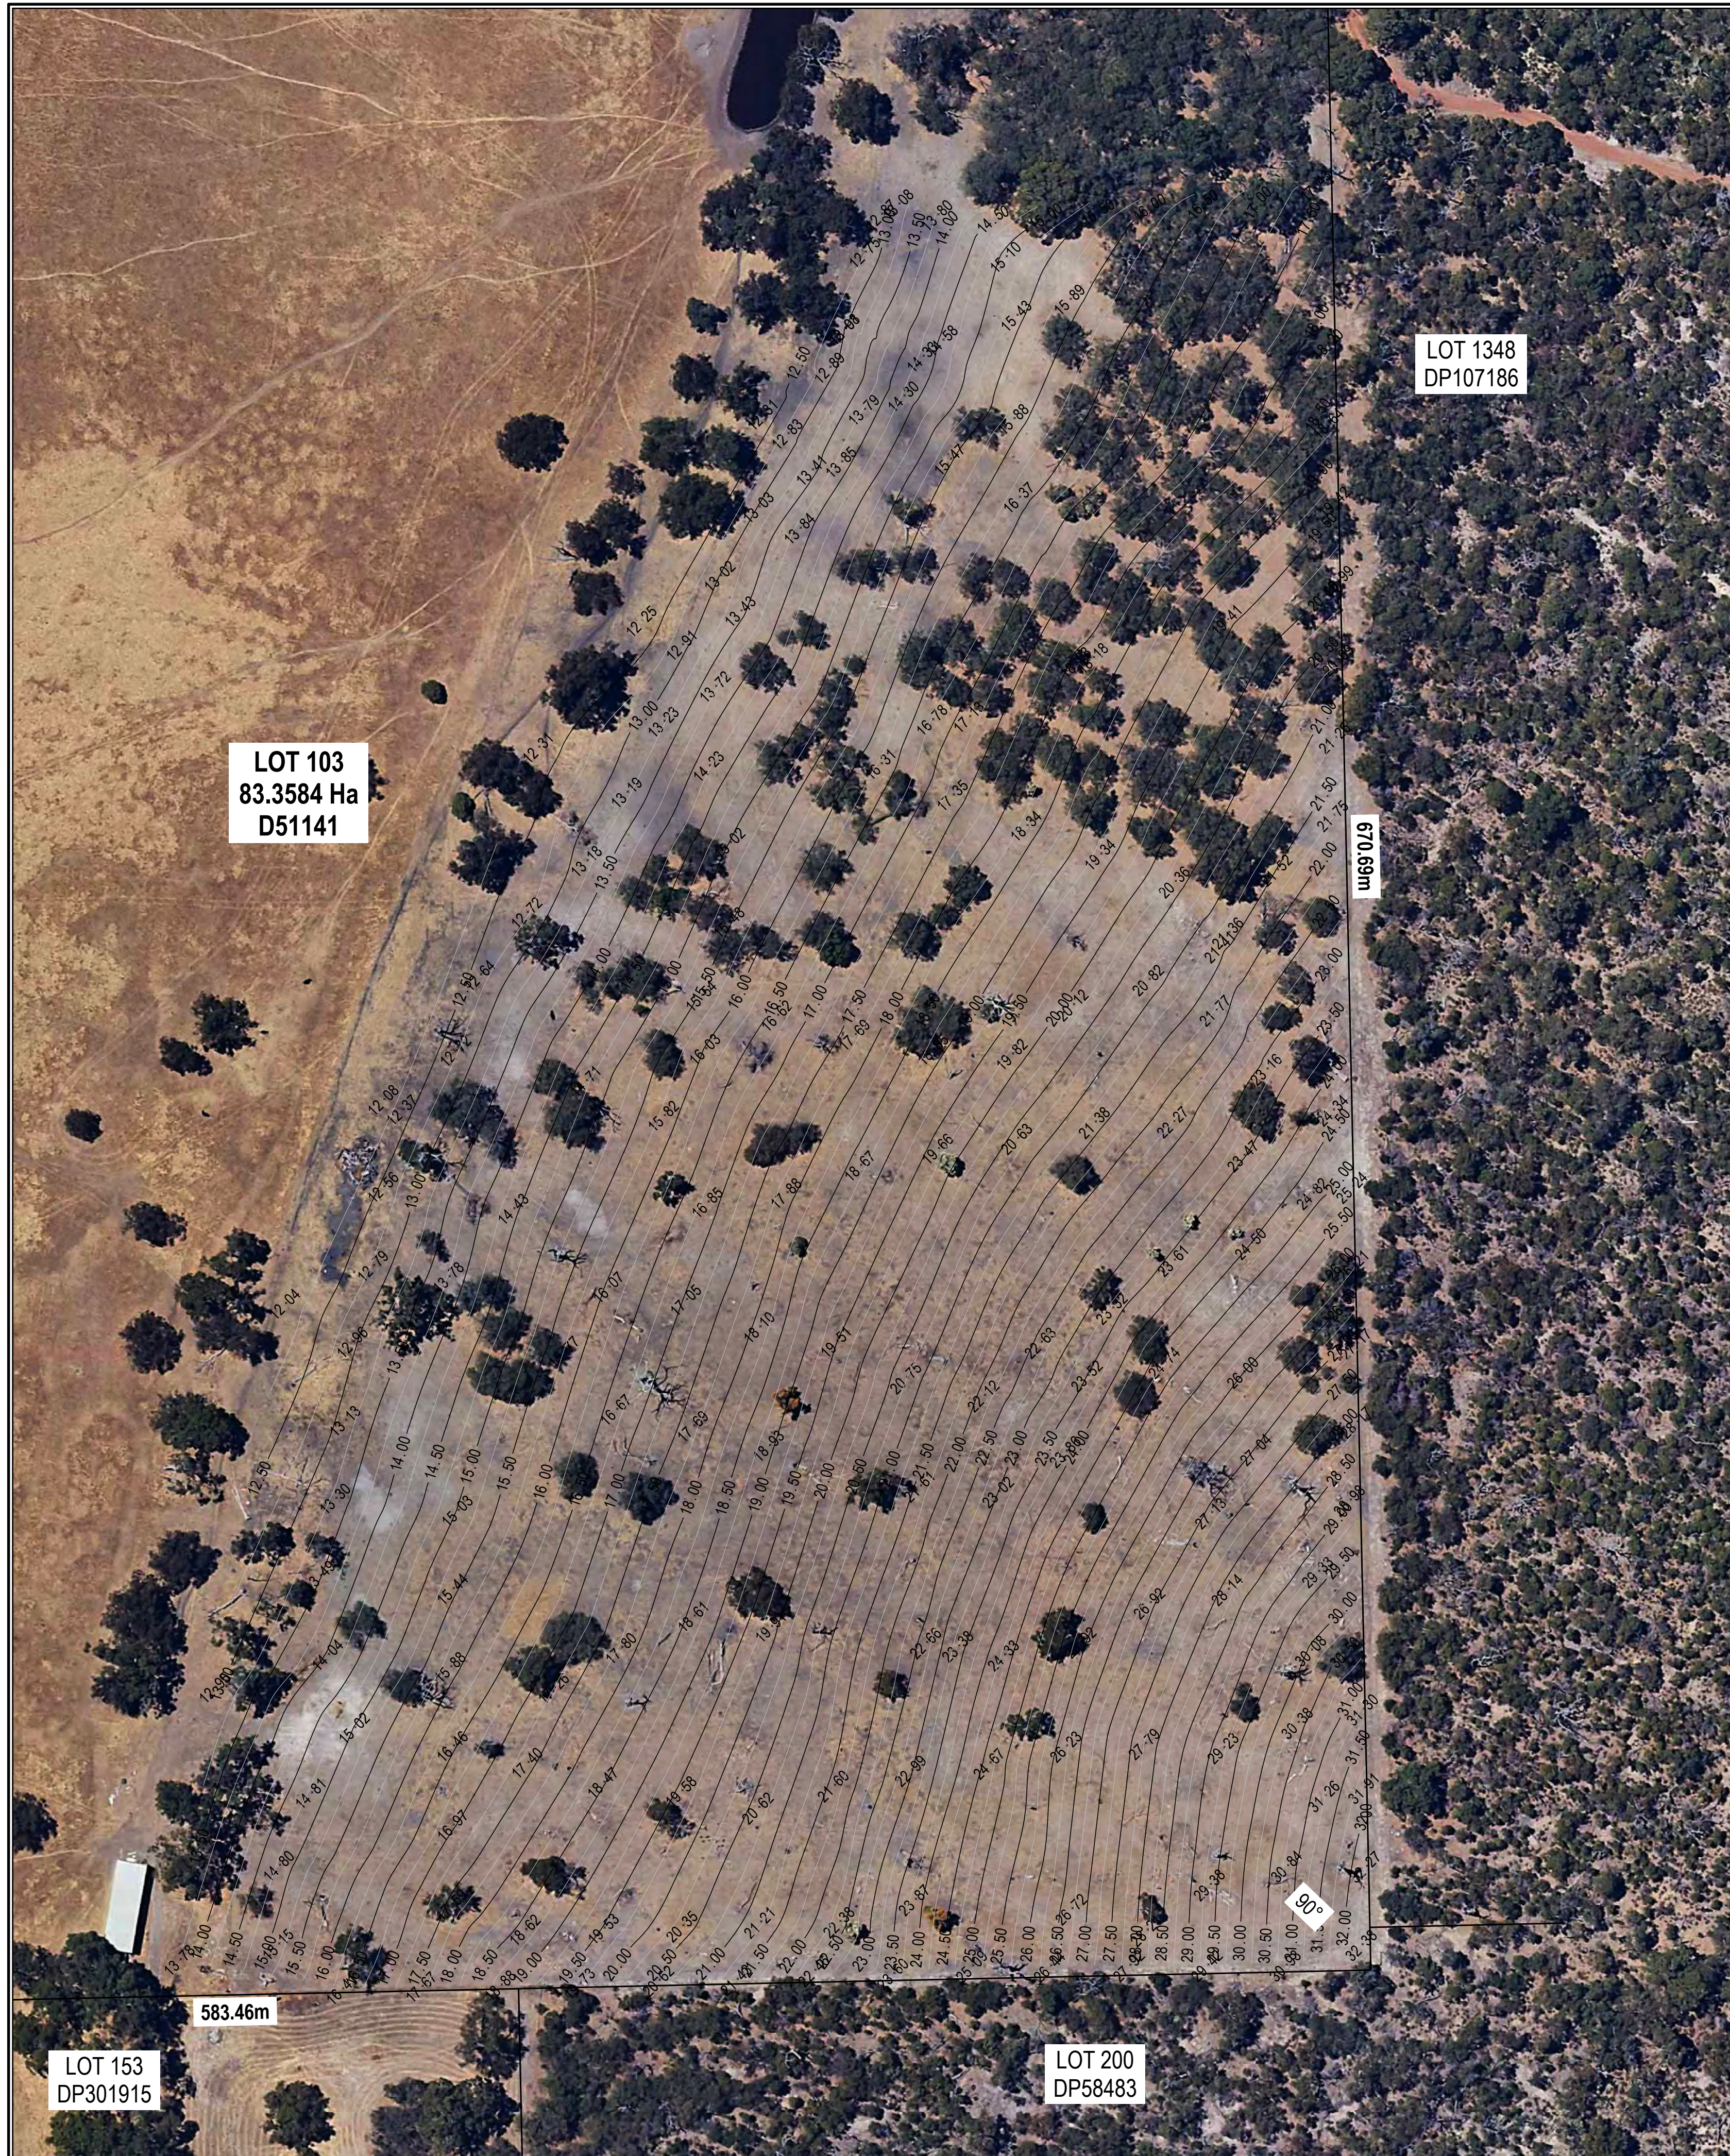
APPENDIX C – SITE CONTOUR SURVEY

LEGEND
 27.13 EXISTING SURFACE HEIGHT
 BOUNDARY

NOTES:
 1. Limited boundary marks found. Boundary resurvey recommended if building on or close to boundary.
 2. Datum is AHD established from VRS / GPS.
 3. Above ground services located by survey. Underground services plotted from plans supplied by the relevant authorities.
 No liability is accepted for errors in underground service locations. All services to be located on site prior to any work being done.
 4. No boundary marks found unless otherwise noted.
 5. Contour interval is 0.25m.
 6. PDF to be used in conjunction with DWG file supplied.
 Some point heights may have been omitted for clarity; see DWG file.

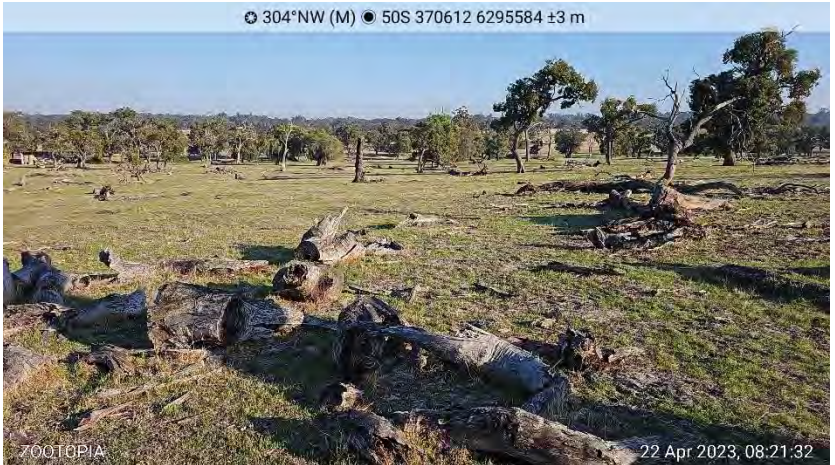
Fauna Habitat Description	Example Image
<p>Cleared pasture with widely scattered trees (jarrah, marri and dead unidentified species).</p> <p>Makes up most of the survey area.</p>

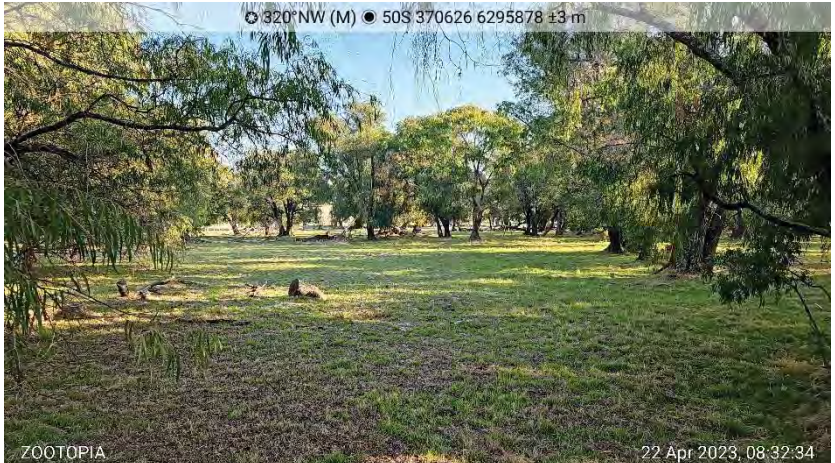
<p>Peppermint low woodland with very occasional emergent eucalyptus (jarrah/marri/dead) over grassland/bare ground.</p> <p>Confined to the northeast corner of the survey area</p>

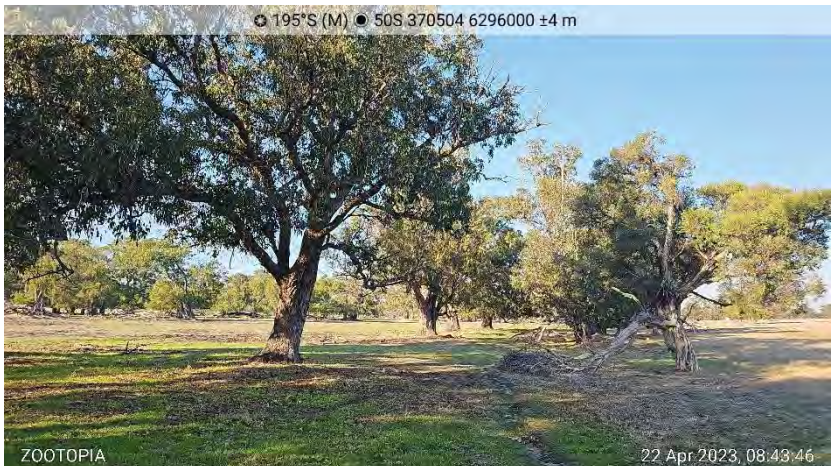
<p>Scattered flooded gum and paperbarks.</p> <p>Confined to the western boundary of the survey area.</p>

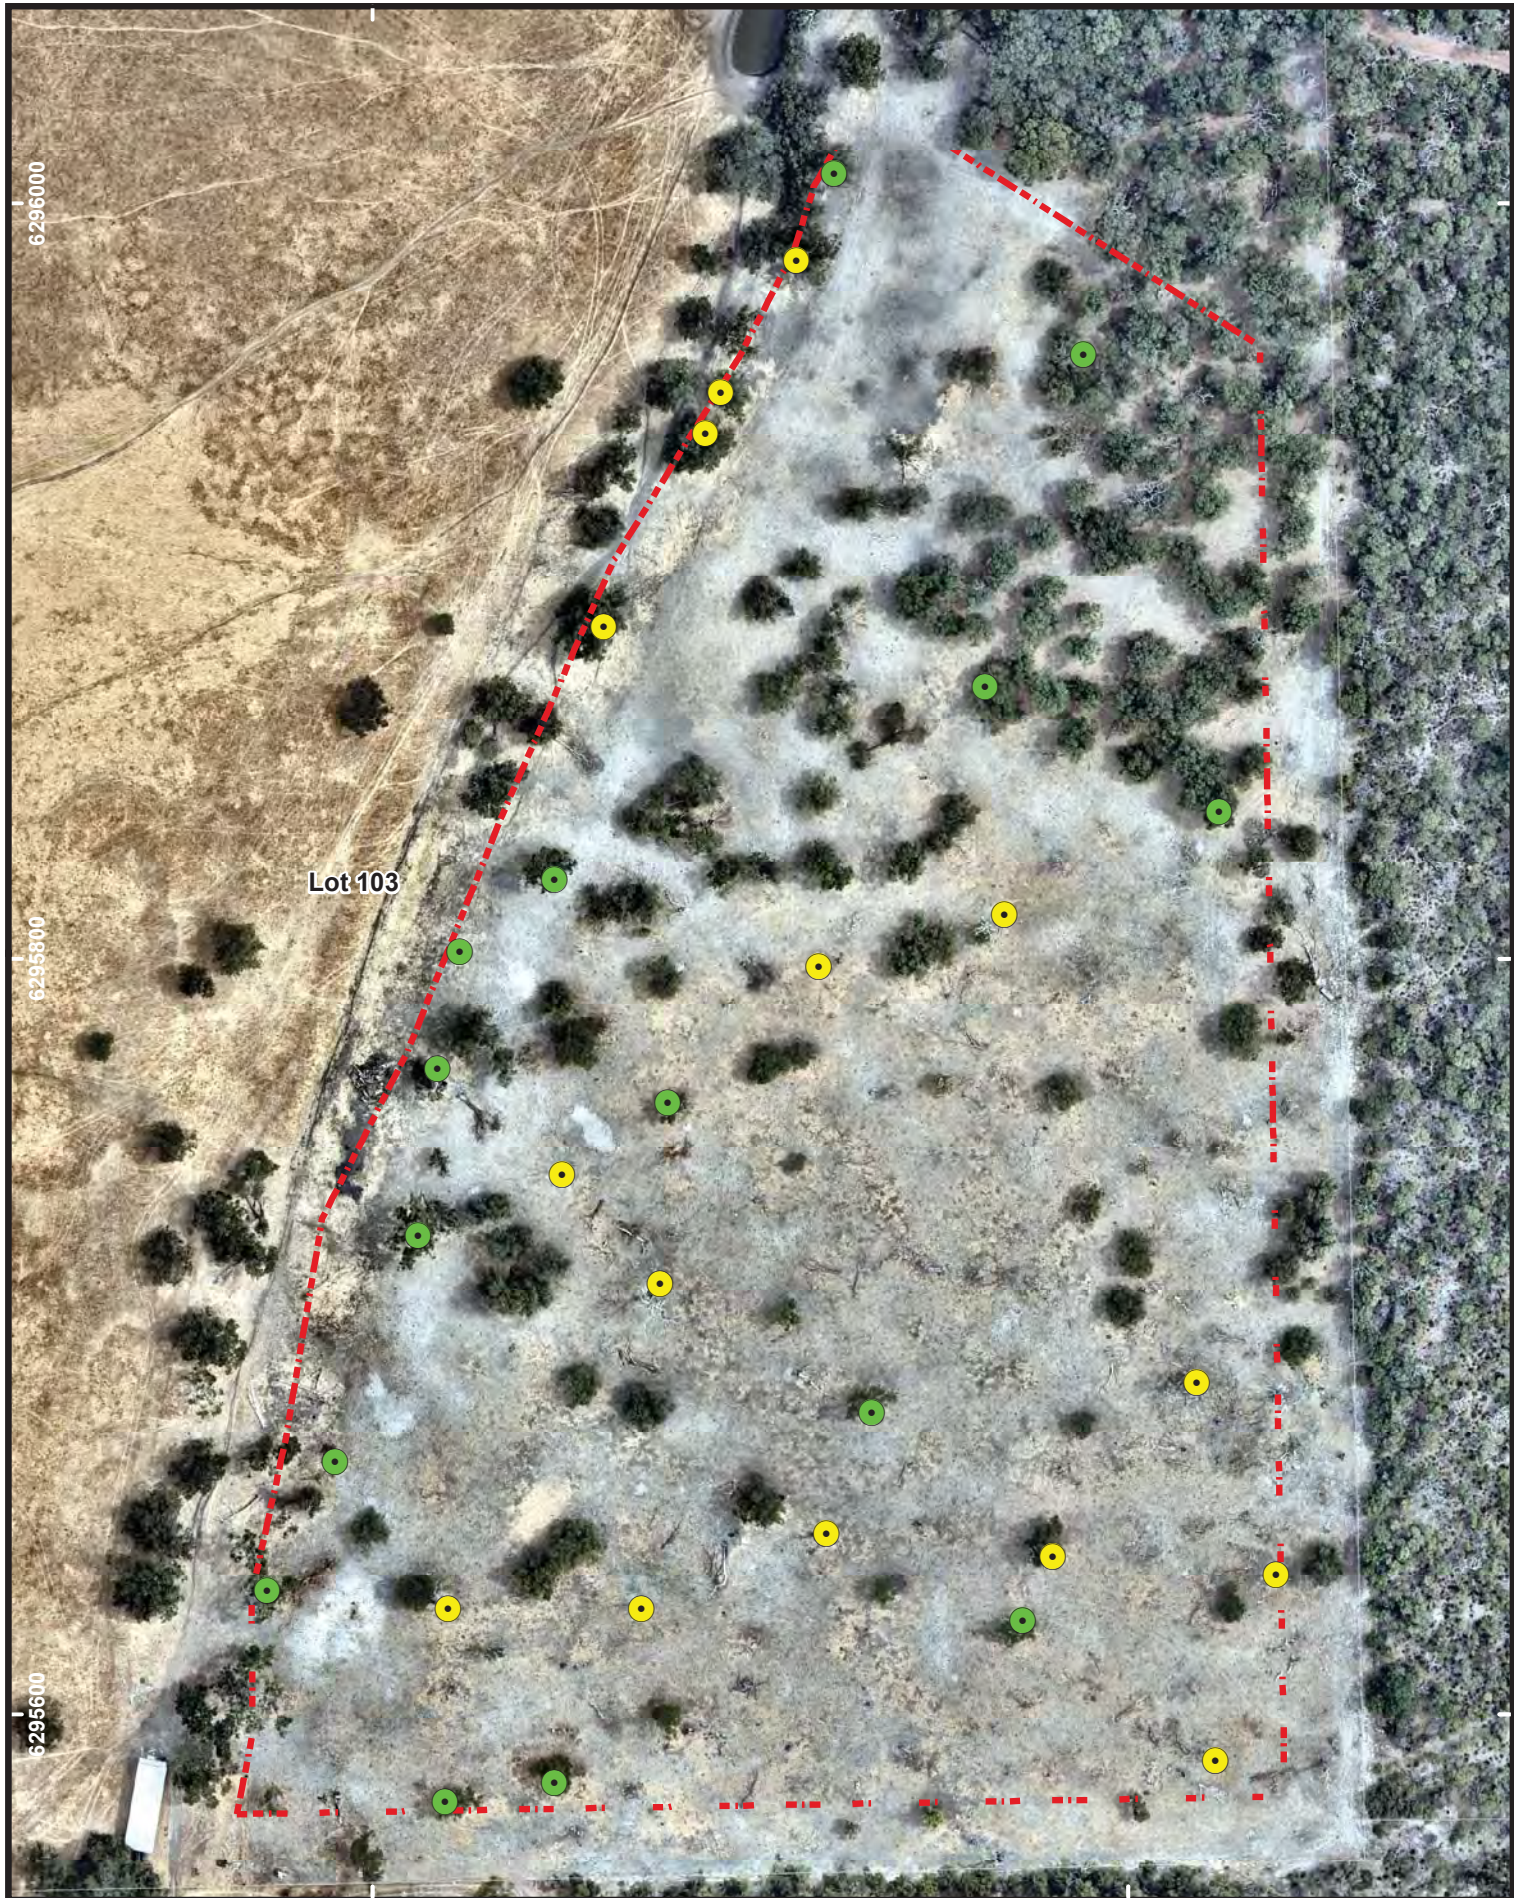
Projection/Coordinate System: UTM/MGA Zone 50 Figure: 2

**Survey Area
 Habitat Trees
 (DBH >50cm)**

A summary of the habitat trees observed is provided in Table 2. The locations of habitat trees are shown in Figure 4.
