Edgeloe Engineering Pty Ltd ABN 31 639 695 088

INTRODUCTION

Edgeloe Engineering has been engaged by Ocean Gardens Pty Ltd to provide Civil Engineering consultancy services to support the preparation of the Development application for the development of Lots 12, 28, &165 Capel Drive Capel for a mixed-use Development.

This report assesses and reports on the servicing requirements and proposed servicing strategy for the proposed development.

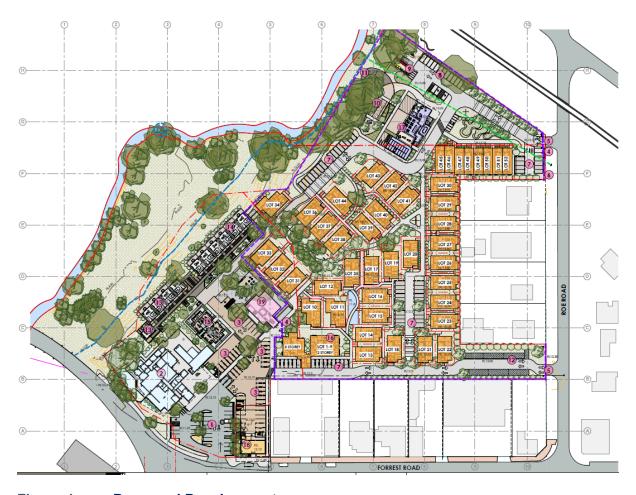
The proposed development is shown in Figure 1 and consists of:

- Retention of existing Capel Tavern
- Short Stay accommodation
- Short Stay facilities
- Over 55 accommodation
- Over 55 facilities
- Mixed Use development
- Foreshore easement

Figure 1 Proposed Development

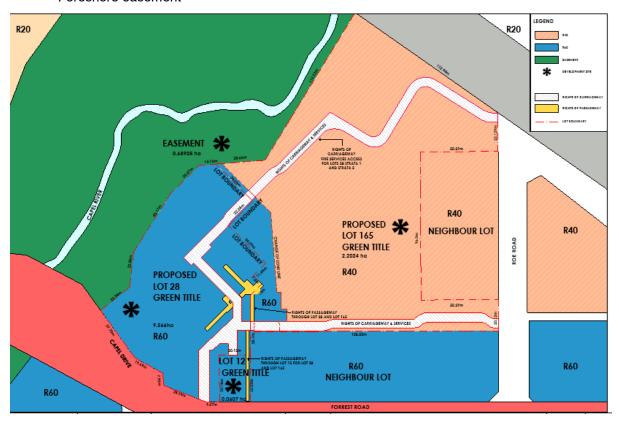
The existing lots 12, 28, &165 will be amalgamated and 3 new green title lots created as shown in Figure 2 and consisting:

- Lot 28 -R60
- Lot 165 R40 & R60
- Lot 12- R60
- Foreshore easement

Figure 2 Proposed Lots

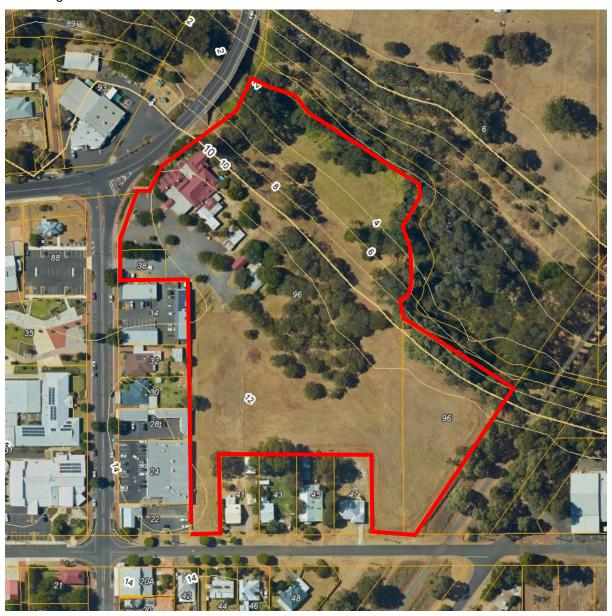
A full feature survey has been undertaken across the site and a summary of general contours is shown in Figure 3 with the terrain shaded in Figure 4.

The site generally falls from RL 13 at the south east to RL 12.0 along the edge of the river bank and then drops to approximately RL 3.0 along the edge of the Capel River.

Figure 3 Existing Site Levels

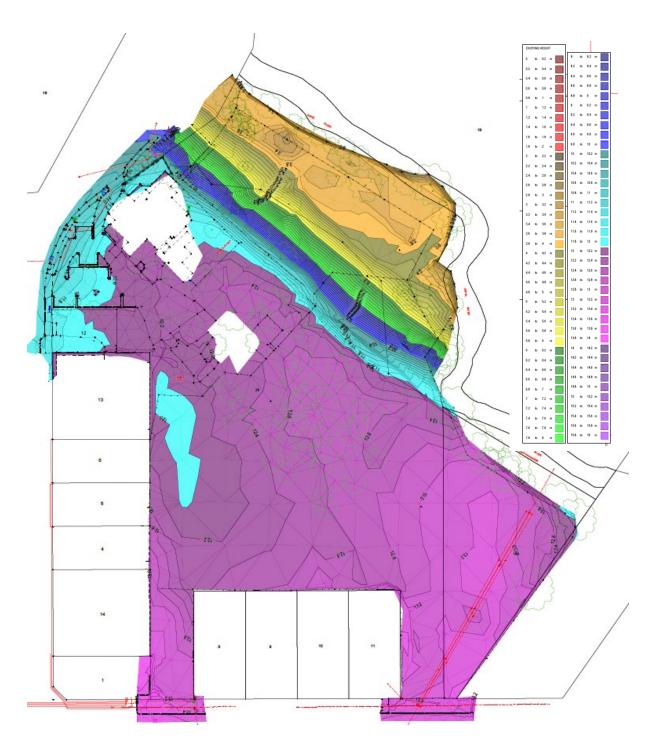
There is a depression in the centre of the site at approximately RL 11.8 that appears to be a trapped low area and will require filling. This is evident in Figure 4.

Figure 4 Existing Site Levels

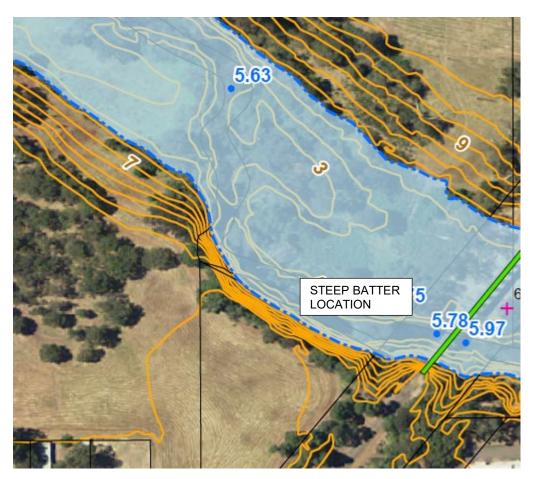
Adjacent the river bank there is a very steep batter section as shown in Figure 5 and this is being further investigated by GALT Geotechnical Engineers to determine slope stability.

Figure 5 Existing Steep Batter (DWER Flood mapping extract)

The effects of possible continual downstream erosion on the adjacent downstream batter will also be investigated by GALT in the detail design phase and prior to issue of any building approvals for works on the site.

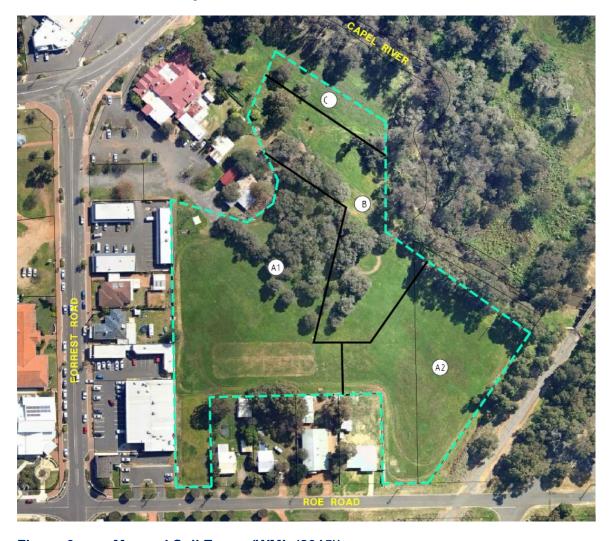
Based on test pits and soil testing across the site 4 distinct Zones, A1, A2, B & C were determined across the site as shown in Figure 6.

Figure 6 Mapped Soil Zones (WML (2015))

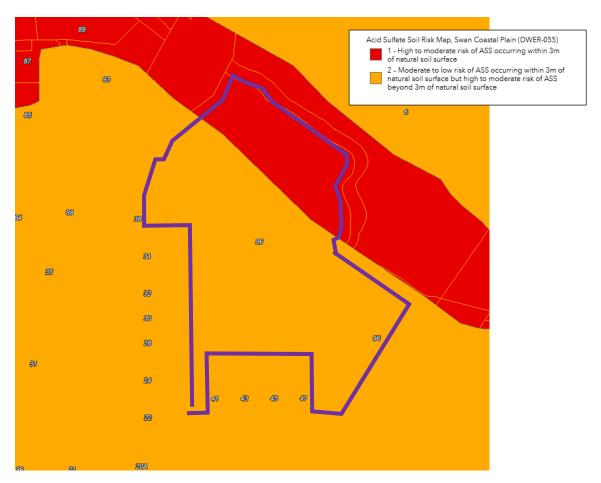
Acid Sulfate Soils were assessed by WML (2015). The DWER ASS risk map as shown in Figure 7 indicates the majority of the site is a Moderate to low risk, however the flat low lying portion of the site next to the Capel River (Area C) is of High to Moderate. Preliminary field testing for ASS conditions undertaken in test pit TP9 and TP8 showed no evidence of ASS. Further investigations would be undertken on this site prior to any ground disturbing works occurring so appropriate ASS management practises can be used.

Figure 7 ASS Mapping

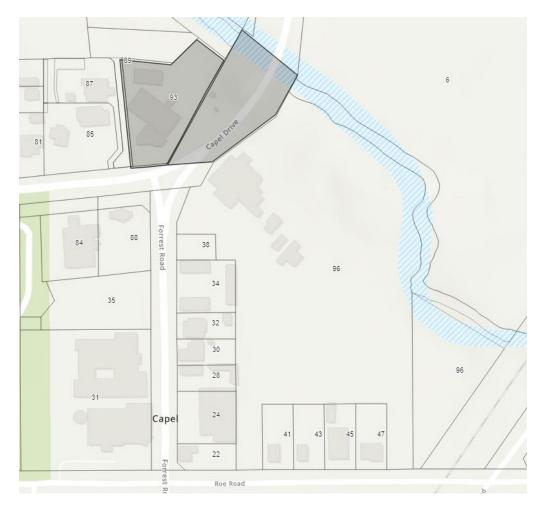
The DWER Contaminated sites data base shows a contaminated site to the west of the site as shown in Figure 8.

This site is related to leakage reported from the Service Station on the west side of Capel Drive and Visual and olfactory evidence of hydrocarbons (such as from petrol or diesel) have been identified down-gradient of a service station in the Capel River and along the riverbank.

Figure 8 Site Contamination, DWER Contaminated sites data base.

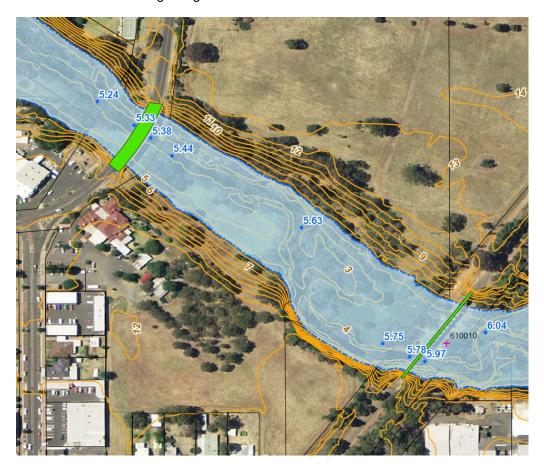
DWER Flood mapping for the Capel River is shown in Figure 9. All development on the site is required to be a minimum of 500mm above the flood levels.

Figure 9 DWER Flood mapping

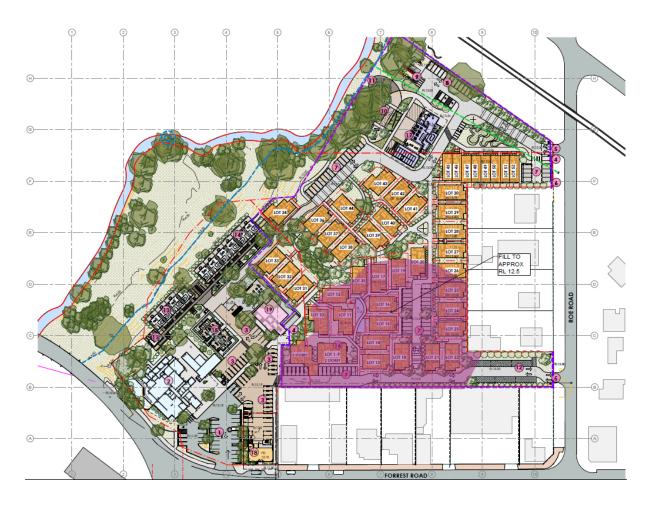
The indicative extent of fill is shown in Figure 10 and will remove the trapped low point within the central portion of the site.

Figure 10 Indicative fill area

This will be further refined at detail design stage and will be determined in conjunction with subsoil drainage on the site to control perched groundwater that could occur on this site.

This fill will require a retaining wall along the southern boundary of the site abutting lots fronting Forrest Road. A Twinside wall of less than 1m high is anticipated. This type of wall is easily removed if required to access the Water Corporation sewer along this alignment for longer term maintenance.

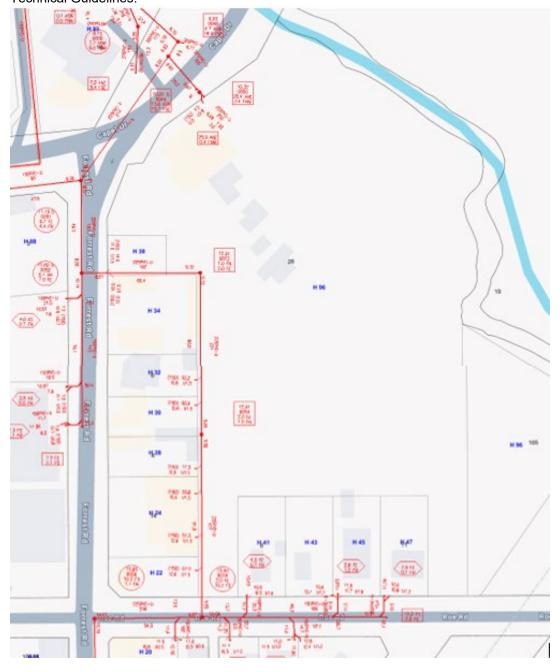
The site and its existing lots are serviced by Water Corporation sewer network as shown in Figure 11.

Figure 11 Water Corporation Sewer, ESINET (2025)

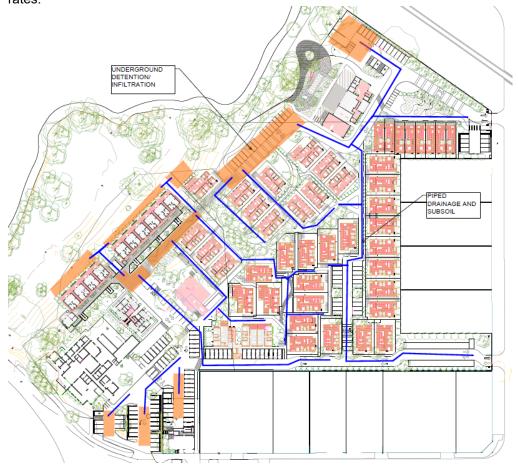
Runoff from the site would be captured internally in a system of shallow swales, drainage pits and pipes for conveyance to the below ground storage devices.

The indicative drainage scheme is shown in Figure 12 and would be further detailed at the detail design and Building Permit phase of the project.

Figure 12 Site Drainage Concept

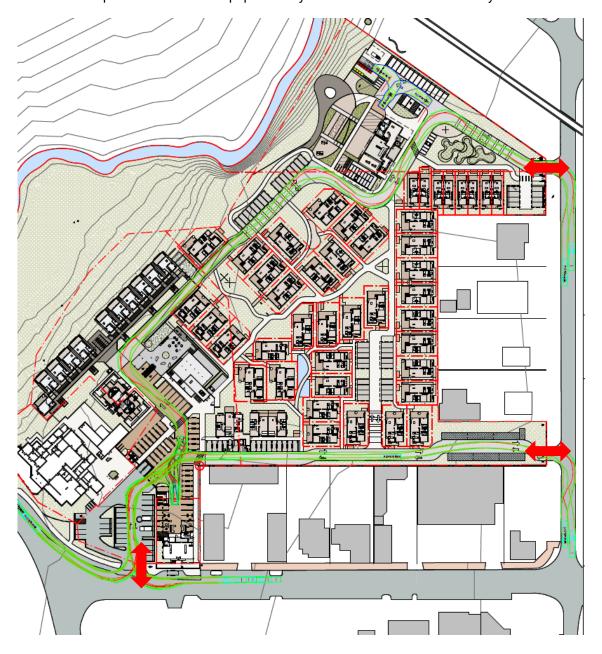
Key access points to the site are as shown in Figure 13 and are subject of a separate traffic study.

These include a single access point onto Forrest Road and two access points onto Rowe Road.

Figure 13 Proposed Access Points

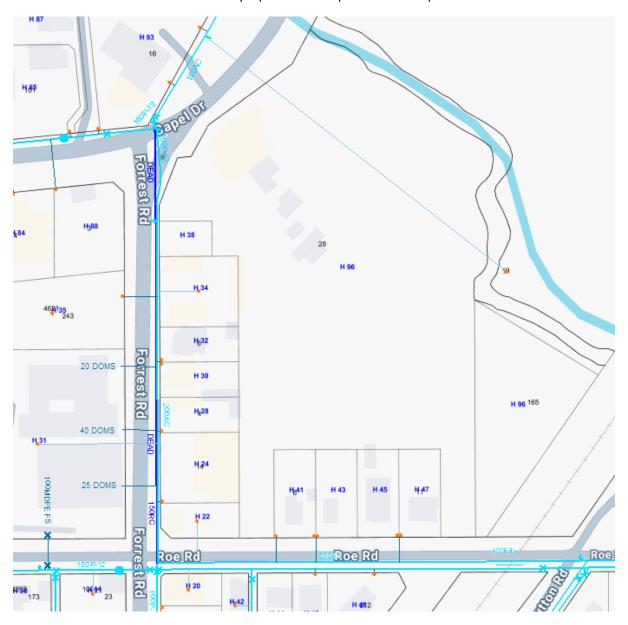
The site and its existing lots are serviced by Water Corporation water network as shown in Figure 14.

There is a 200 RC main on Forrest Road and 200 AC and 150 RC mains along Roe Road.

Figure 14 Water Corporation Water, ESINET (2025

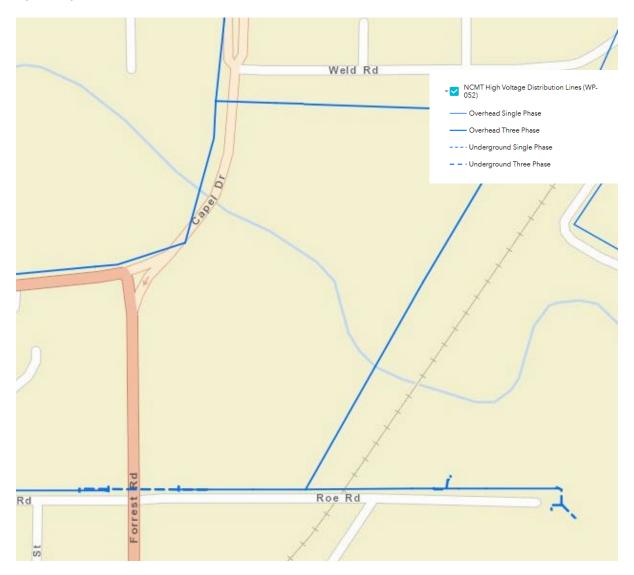
The site currently serviced by Western Power overhead and underground network as shown in Figures 15 and 16.

Figure 15 Existing Overhead Power Infrastructure

A 3 phase HV overhead line crosses the south eastern portion of the development. A set back will be required from this line so no development occurs within its easement.

A sag study will also be required to ensure sufficient clearance under the power line for all proposed development and road and access crossings.

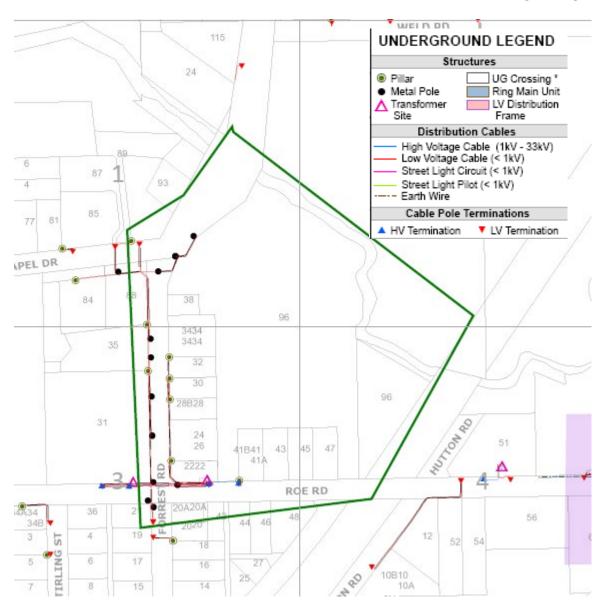
Low voltage underground cables are also located adjacent the site as shown In Figure 16.

Figure 16 Existing Underground Power Infrastructure

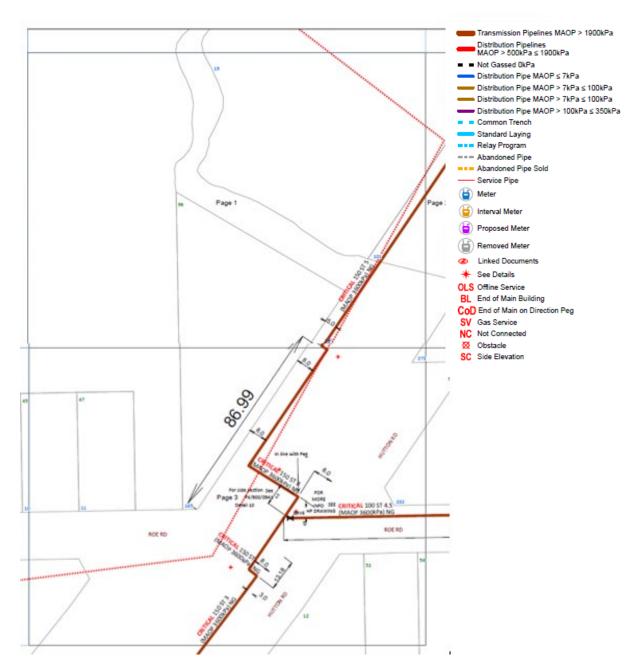
There is a Gas transmission pipeline located along the rail corridor crossing Roe Road as shown in Figure 17 but this is not suitable for delivery of gas to development without a pressure reduction station being installed.

This pipeline is only 5m off the boundary of Lot 165 and no works are permitted within 15m of the pipeline without prior approval from ATCO.

Figure 17 Existing Gas Transmission Pipeline
