# ENVIRONMENTAL MANAGEMENT PLAN

**LOTS 167 (No.365), 204, 205, 206 & 207 (No.363)  
MALLOKUP ROAD AND LOTS 159, 168 & 203  
LUDLOW ROAD NORTH, STIRLING ESTATE**

**JUNE 2026**

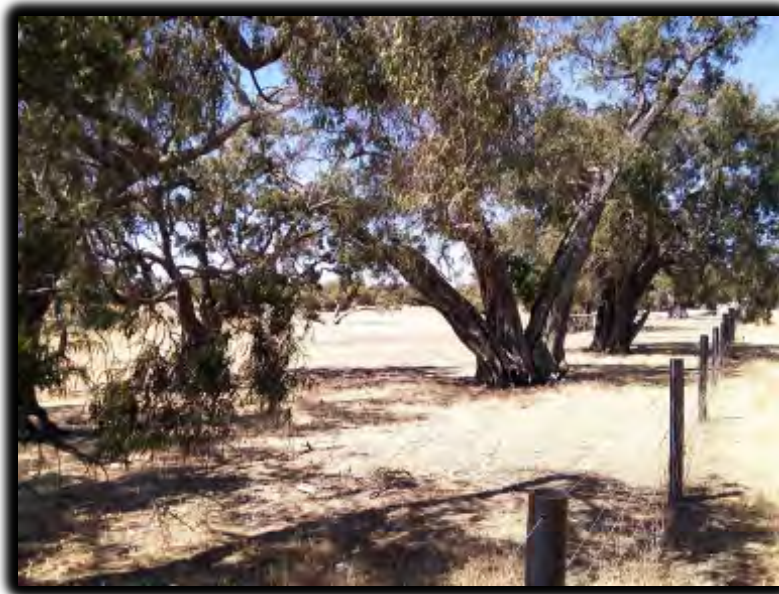
**Plate 1: Vegetation within the subject site. Condition is rated as 'Poor' with no native species present (Plantecology Consulting 2025).**

Furthermore, a vegetation survey by Plantecology Consulting (2025) found the vegetation within the subject site to be in a 'Poor' condition (refer to **Plate 1**). The subject site is comprised of pasture areas that have been 'parkland cleared' apart from paddock trees consisting mainly of planted *Eucalyptus gomphocephala* (Tuart) and *Agonis flexuosa* (Peppermint). The landowner has advised that all remaining vegetation within the subject site has been planted and does not comply with the definition of 'native vegetation' pursuant to the *Environmental Protection Act 1986*.

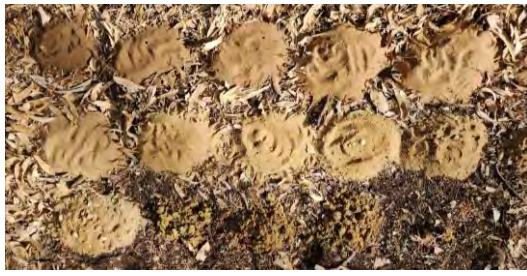
**MB1**

support	backfill	water	Slot / Screen Depth	Depth (metres)	Soil Characteristics					
					Colour	Particle Size	Texture	Organic Content	Moisture	Comment
PVC (Class 9)	GRAVEL	▽	[Screen Pattern]	5.5m	Light Brown	Fine to Medium	Gravelly Sand (limestone and shell)	None	Dry	
				6.0m	Light Brown Beige				Moist	
				6.5m						
				7.0m	Dark Beige		Sand		Saturated	
				7.5m						
				8.0m						end of hole at 8.0 m
				8.5m

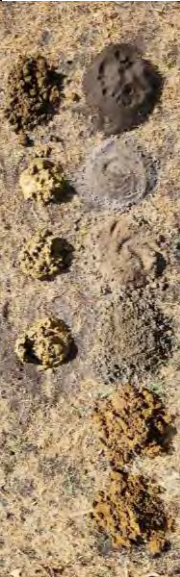
0.5m	Dark Grey Black	Fine to Medium	Sand	Medium	Dry

1.0m	Dark Grey			Low		
	1.5m			Dark Grey Light Brown				Slightly Moist		
	2.0m			Dark Grey Brown	Clayey Sand			Moist		
	2.5m			Brown						
	3.0m						None			
	3.5m			Dark Brown	Sandy Clay					
	4.0m							Saturated		
	4.5m			Light Brown	Clayey Sand					
				5.0m					end of hole at 5.0 m

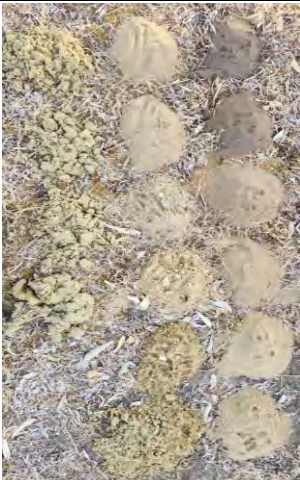
**MB3**

support	backfill	water	Slot / Screen Depth	Depth (metres)	Soil Characteristics					
					Colour	Particle Size	Texture	Organic Content	Moisture	Comment
PVC (Class 9)	GRAVEL	▽	[Screen]	5.5m	Beige Yellow	Fine to Medium	Gravelly Sand (limestone and shell)	None	Slightly Moist	
				6.0m					Moist	
				6.5m	Dark Beige		Sand		Saturated	
				7.0m						
				7.5m						
				8.0m	Beige Brown	Fine	Clayey Sand			end of hole at 8.0m
				8.5m

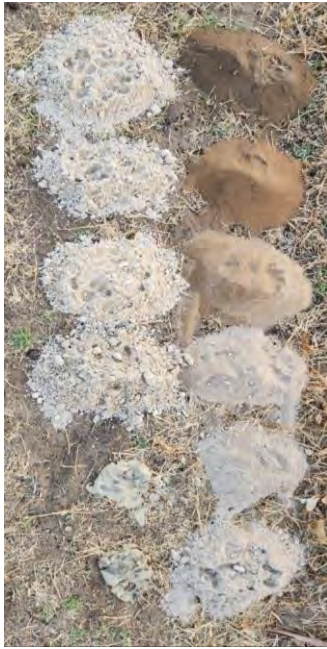
**MB4**

support	backfill	water	Slot / Screen Depth	Depth (metres)	Soil Characteristics					
					Colour	Particle Size	Texture	Organic Content	Moisture	Comment
PVC (Class 9)	GRAVEL			5.5m	Light Beige Grey	Fine to Medium	Gravelly Sand (limestone)	None	Saturated	
				6.0m			Clayey Sand			
					Grey					
				6.5m	Grey Brown	Fine	Clay		end of hole at 6.5m	
				7.0m

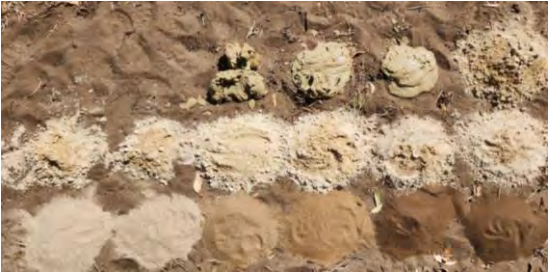
**MB5**

support	backfill	water	Slot / Screen Depth	Depth (metres)	Soil Characteristics					
					Colour	Particle Size	Texture	Organic Content	Moisture	Comment
PVC (Class 9)	GRAVEL	▽	[Grid]	5.5m	Beige		Gravelly Sand (limestone)	None	Slightly Moist	
				6.0m					Moist	
				6.5m	Dark Beige	Fine to Medium	None	Saturated		
				7.0m						
				7.5m	Clayey Sand					
				8.0m				end of hole at 8.0 m		
				8.5m

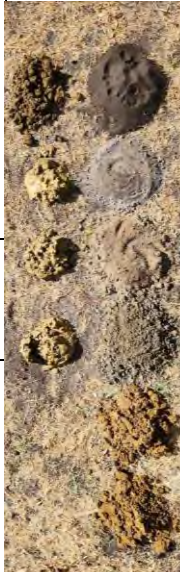
**MB2**

support	backfill	water	Slot / Screen Depth	Depth (metres)	Soil Characteristics					
					Colour	Particle Size	Texture	Organic Content	Moisture	Comment
PVC (Class 9)	CEMENT	▽		0.5m	Dark Grey Black		Sand	Medium	Dry

1.0m	Dark Grey		Low			
	1.5m			Dark Grey Light Brown	Clayey Sand		None	Slightly Moist		
	2.0m			Dark Grey Brown				Moist		
	2.5m			Brown	Fine to Medium		None	Saturated		
	3.0m			Dark Brown	Sandy Clay					
	3.5m								Clayey Sand	
	4.0m			Light Brown						
4.5m										
5.0m				end of hole at 5.0 m

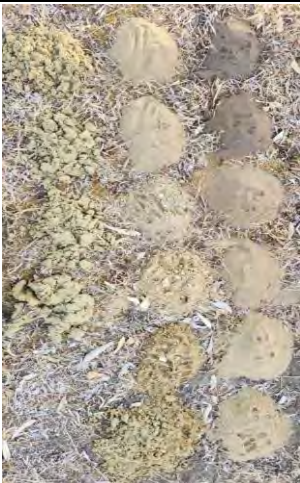
**MB3**

support	backfill	water	Slot / Screen Depth	Depth (metres)	Soil Characteristics					
					Colour	Particle Size	Texture	Organic Content	Moisture	Comment
PVC (Class 9)	GRAVEL	▽	[Grid]	5.5m	Beige Yellow		Gravelly Sand (limestone and shell)		Slightly Moist	
				6.0m					Moist	
				6.5m		Fine to Medium		None		
				7.0m	Dark Beige		Sand		Saturated	
				7.5m						
				8.0m	Beige Brown	Fine	Clayey Sand			end of hole at 8.0m
				8.5m

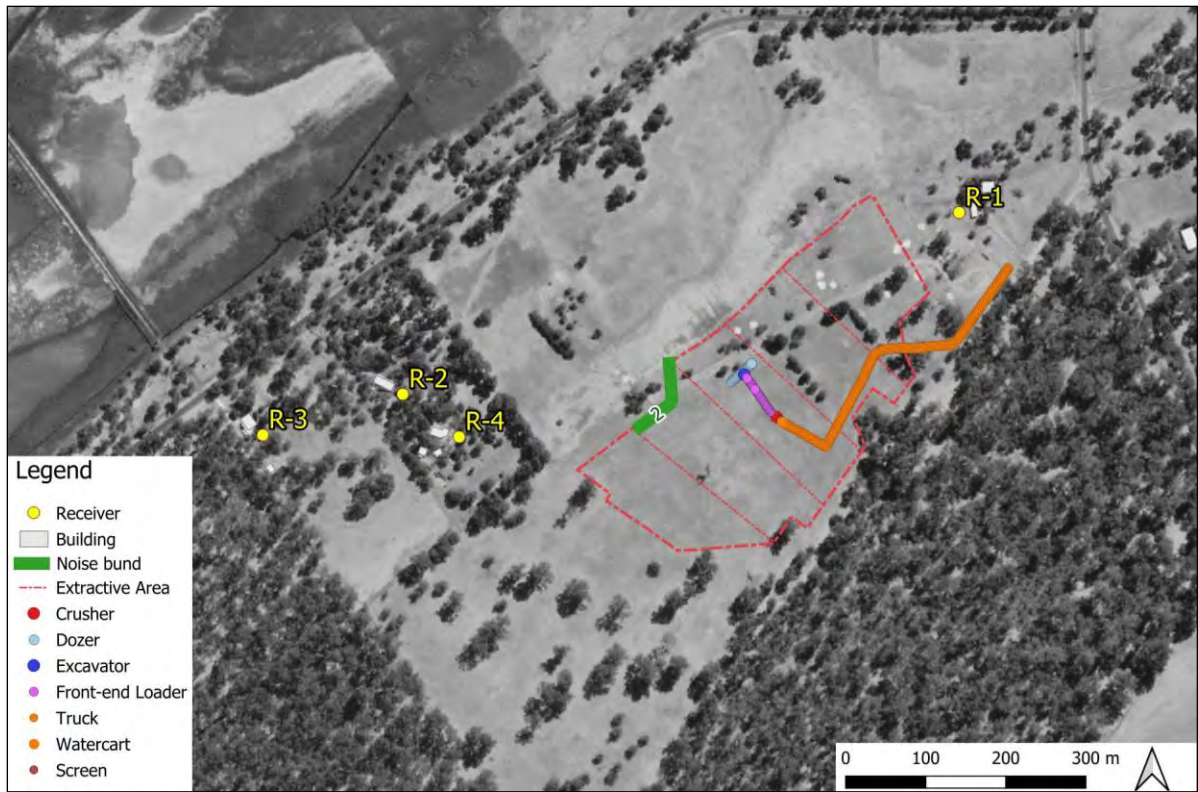
**Figure 5 Sources in Scenario 3**

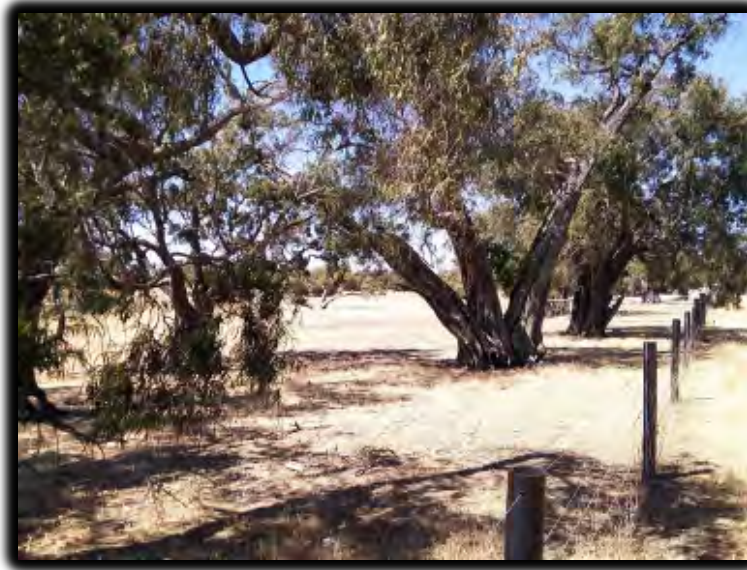
**Plate 1: Vegetation within the subject site. Condition is rated as ‘Poor’ with no native species present (Plantecology Consulting 2025).**
