## Dalyellup Annual Environmental Report - 2023

Tronox Pigment Bunbury Ltd  
ABN 50 008 683 627  
Locked Bag 245, Bunbury WA 6230

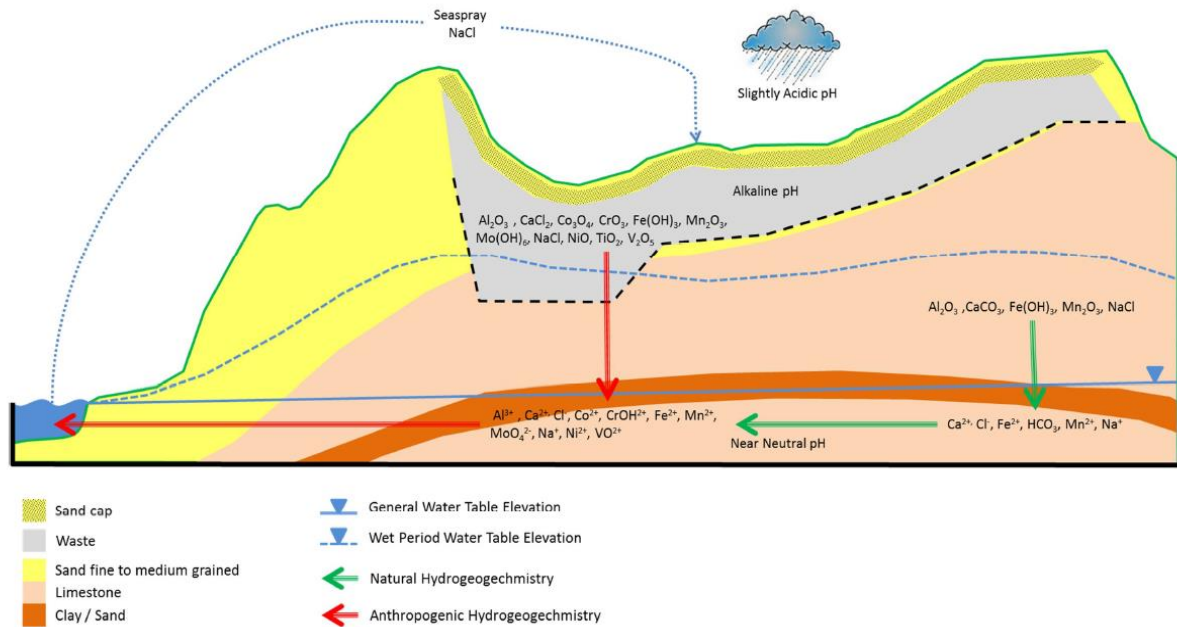
Figure 2 – Conceptual Model of the Site<sup>2</sup>

The superficial aquifer has a saturated thickness at about 10 m beneath the disposal site. Groundwater flow through the superficial formation is towards the ocean where discharge occurs across a seawater interface. The hydraulic gradient is about 1:100. Baseline studies, prior to commissioning the site, recorded electrical conductivities in the order of 1,350  $\mu\text{S}/\text{cm}$ , equivalent to about 800 mg/L TDS. Figure 2 shows a hydrogeological conceptual model of the site.
