Dalyellup Annual Environmental Report - 2024

This report documents the environmental review of the Dalyellup Treated Solid Residue (TSR) disposal facility managed by Tronox Pigments Bunbury Ltd (Tronox). The report is submitted to satisfy the reporting requirements for the period January – December 2024 in accordance with:

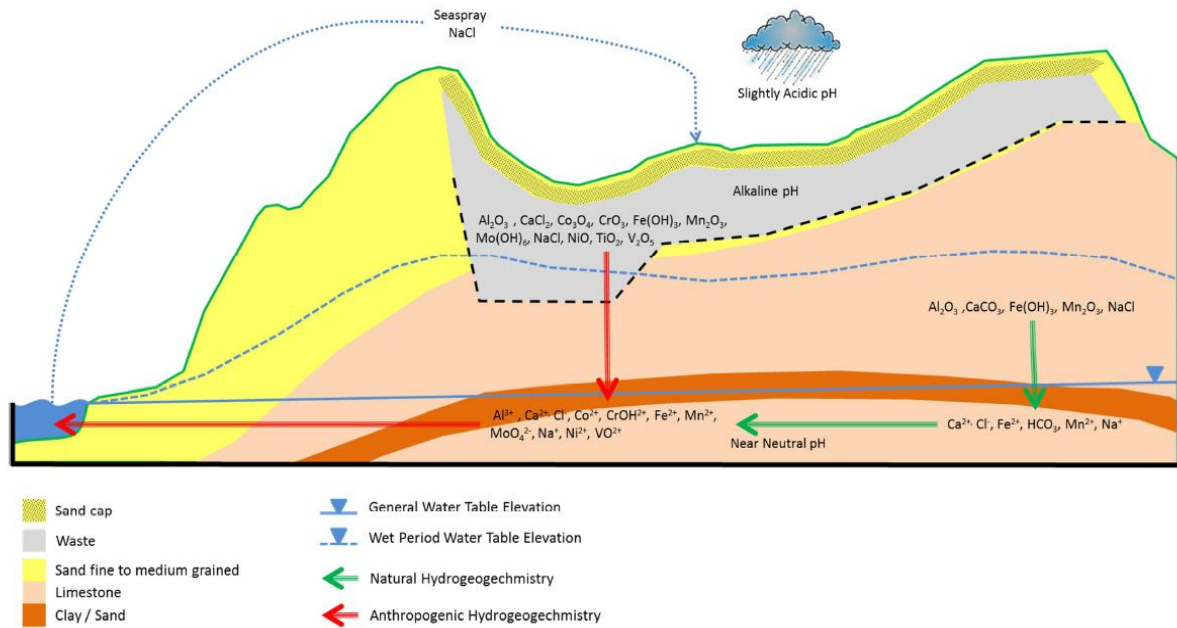
Figure 2 – Conceptual Model of the Site²

The superficial aquifer has a saturated thickness at about 10 m beneath the disposal site. Groundwater flow through the superficial formation is towards the ocean where discharge occurs across a seawater interface. The hydraulic gradient is about 1:100. Baseline studies, prior to commissioning the site, recorded electrical conductivities in the order of 1,350 $\mu\text{S}/\text{cm}$, equivalent to about 800 mg/L TDS. Figure 2 shows a hydrogeological conceptual model of the site.
